Experimental Analysis of Failure of Drive Shafts

Shubham Basu

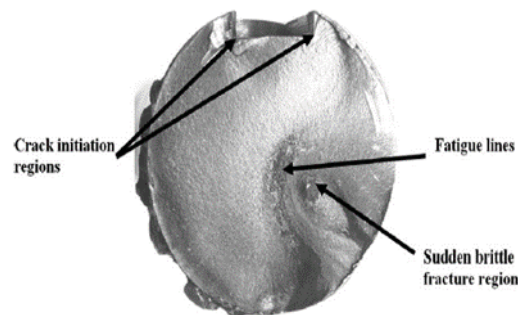
Figure 3. Fracture surface cut section [1]

Visual inspection of the fracture surface revealed the presence of fatigue cycles possibly due to torsion and bending stress acted upon the shaft. It was observed that the crack had initiated along the edges of the keyway and which propagated throughout the entire surface. Further chemical analysis was done using atomic absorption spectroscopy, microstructure of the material was also analysed along with mechanical properties and results confirmed that the material was St52.0. Stress analysis determined that due to very low radius of curvature along the keyway of the shaft there is high stress concentration in that region due to which very high notching effect is seen in that region due to shear and bending stresses. A detailed fatigue stress analysis showed that the design of the shaft had very low fatigue safety factor. Finally finite element analysis of the shaft was done using ANSYS it also revealed high stress concentrations along the sharp edges of the keyway [1].

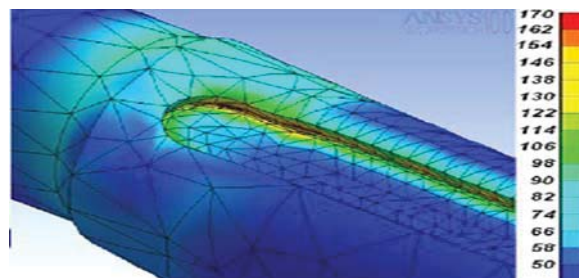
Figure 4. FEA analysis along the keyway [1]

Thus in this investigation it was concluded that failure had occurred at the sharp edges of the keyway which caused high stress concentration in that region which was caused either due to incorrect design or faulty manufacturing process and by increasing the radius of curvature the stress concentration are considerably reduced [1].

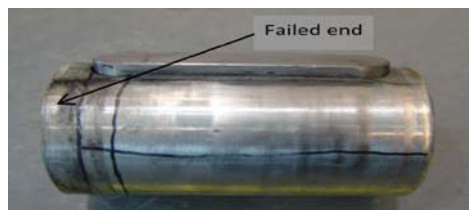
Figure 6. Failed end of the shaft inside coupling [2]

Visual inspection showed that the shaft had failed at the keyway region along corner of the shaft coupling assembly which connects the gearbox and the shaft where sudden steep change of the diameter is seen without much stress relief curve. The gearbox and the motor shaft assembly is hinged instead of being fixed on a solid foundation because of which high stress acts on the region on which failure is observed. Visual inspection of the fracture surface showed fatigue stress lines indicating high stress concentrations caused due to rotational bending. While images from scanning electron microscope showed that surface appearance where the crack initiated differed from the surface where the final fracture occurred that showed evidence of a possible metallurgical change. Metallurgical test revealed that the external surface of the shaft had been welded during a scheduled maintenance and that the fractured surface was affected due to heat generated by the welding process and which caused the material near the welded region to be less endured to fatigue stresses. Chemical analysis showed the shaft material was BS 970 150M19. Mechanical tests such as tensile, toughness, fatigue and hardness test showed that the weld metal has hardness more than the base metal. So it can be concluded that weld metal is brittle in nature whereas the base metal is ductile in nature [2].

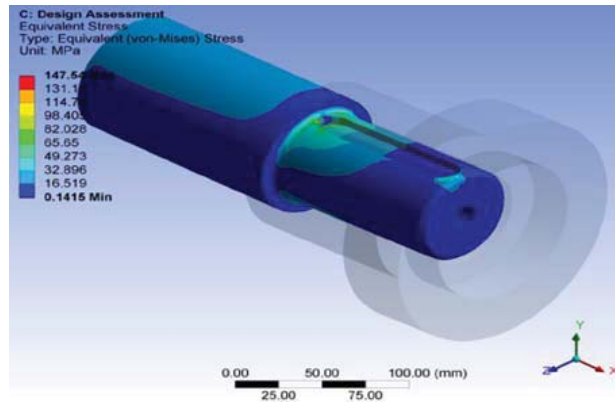
Figure 8. FEA of shaft along shaft keyway [2]

Finite elemental analysis (FEA) of the shaft had been done for stress analysis and the most vulnerable region was analysed as the corner of the keyway where the failure actually happened [2].

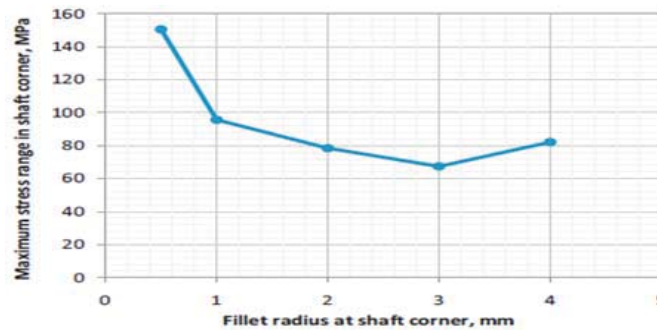
Figure 9. Reduction in stress by increase in fillet radius [2]

The conclusion of this analysis was that the failure was due to the constant load acting to the shaft due to the gearbox and the motor which was aggregated by improper welding process during restoration along the keyway region and that by increasing the fillet radius at the corner of the shaft there considerable reduction in stress acting at the keyway end where the fracture took place [2].

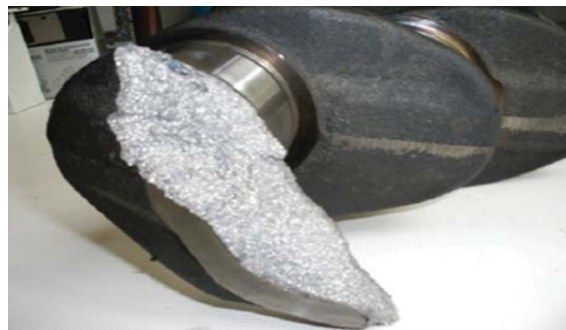
Figure 10. Failed section of crankshaft [3]

Visual inspection of the fracture surface was showed evidence of a brittle fracture which had occurred in the region near the first crankpin [3].

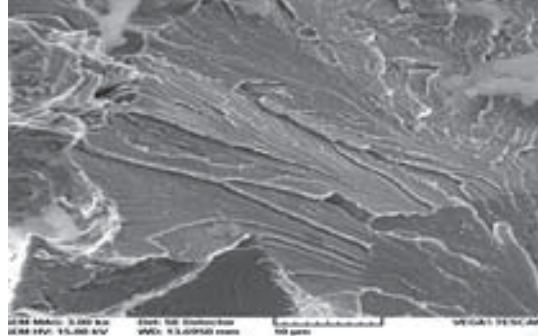
Figure 11. SEM image of fractured surface [3]

Scanning electron microscope (SEM) also showed a crystalline type structure further without any traces of fatigue cycles which further supported that the failure was due to brittle fracture. Since the presence of brittle fracture is observed it is confirmed that the fracture was not due fatigue stress cycles. To find the stress acting on the shaft during operation, dynamic analysis of the journal bearing was done to consider the combined effect of combustion pressure exerted on the piston head which is transmitted through the connecting rod to the bearing attached to the crankshaft and the inertia forces generated due to the rotating movement of the shaft and the reciprocating movement of piston for the analysis of the stress developed along the crankshaft region where failure took place during individual combustion of the cylinders during different cycles [3].

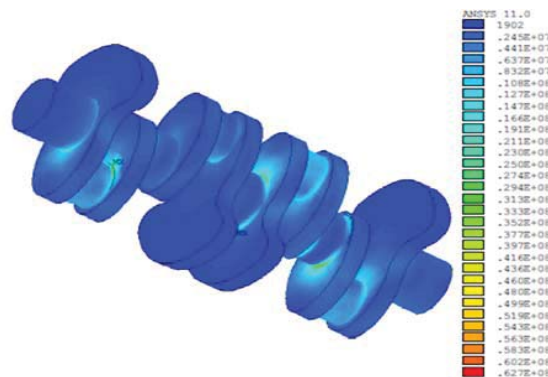
Figure 12. Equivalent von Mises stress distribution using FEA [3]

The von Mises stress distribution of the entire crankshaft showed that the maximum stress which was generated during the combustion of the third cylinder was just 15% of the yield strength of the material which was an evidence that even due the maximum stress developed during the operation of the crankshaft fatigue failure is not possible [3].

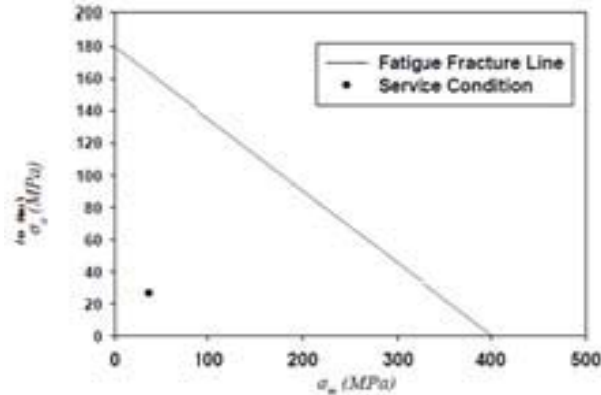
Figure 13. Soderburg diagram of the shaft [3]

This conclusion was even more supported by the Soderburg diagram result which had revealed that the operational life of the crankshaft lied in the well within the safe region and that fatigue failure was not the cause of the fracture. The investigation can be concluded that the failure of the shaft was not due to improper design and material selection such as in the above cases but due some manufacturing processes like fillet rolling of the crankshaft [3].

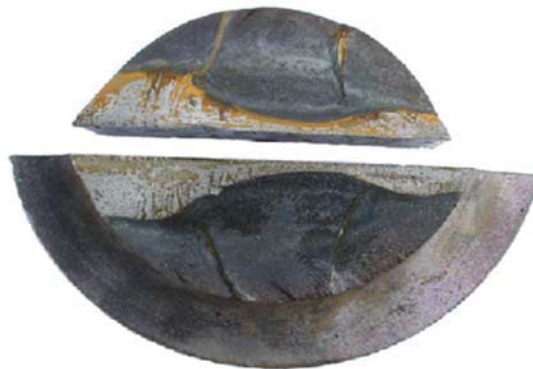
Figure 14. Fracture surface of shaft [4]

Visual inspection showed that as it was observed in the first two cases that was discussed in this paper, this shaft also seem to have been improperly designed which caused regions of high stress concentrations along some regions of the shaft. Laboratory examination of the fractured surface showed corrosion effect sites on the fracture surface along with this conclusion it also revealed the crack had initiated at the shaft surface at three points and which meshed into a common region causing the final failure [4].

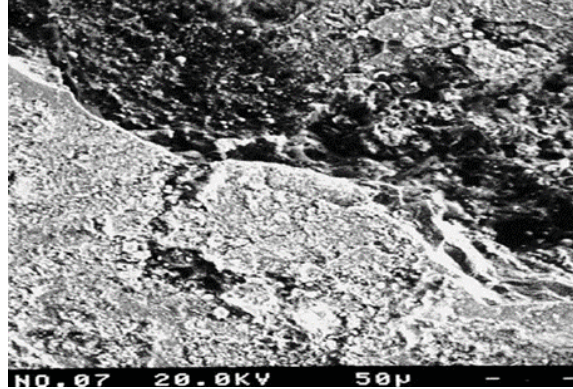
Figure 15. SEM image of the fracture surface [4]

Scanning electron microscope images showed that the crack had initiated from the surface of the shafts where effects of corrosion such as corrosive spots were observed along with evidence of fatigue stress cycles which had acted upon that region [4].

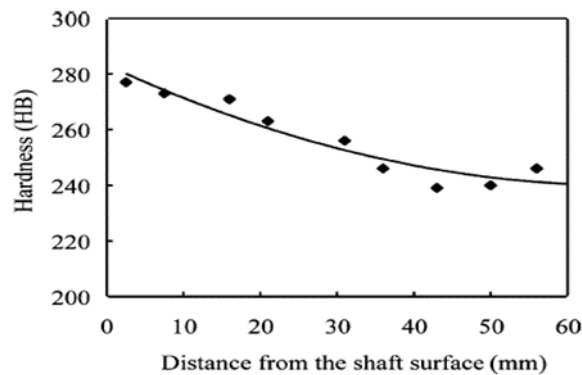
Figure 16. Hardness variation in shaft radially [4]

Metallographic examination revealed that the shaft was not quenched and tempering of the shaft was not done properly so only the outer part of the shaft was hardened but the centre of the shaft remained unhardened because of which made the central part of the shaft is more vulnerable to fatigue failure. Finite element analysis of the shaft was done using ANSYS 7.0 which revealed that the material chosen for the replacement shaft i.e. 35CrMo had less resistance to corrosion under the same loading condition than the original shaft. Thus it was finally concluded that the shaft failed due to combined effect of fatigue cycles and corrosive environment which was aggregated by faulty design and incorrect material selection [4].

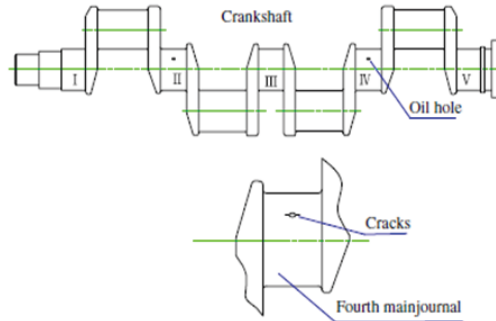
Figure 17. Schematic diagram of the failed crankshaft [5]

During inspection of the crankshaft four cracks were noticed around the fourth journal bearing region along with complete failure of the main bush causing the copper cylinder inside the bush to completely wear off [5].

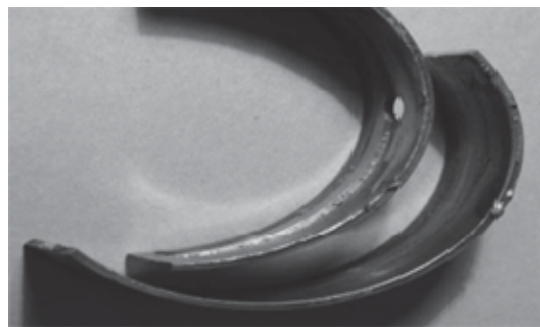
Figure 18. Failed main bush of the shaft [5]

Colour changes were also observed in the journal bearing with blue and black mark zones on the outer surface of the bearing which was enough evidence to conclude that it was caused due to large amount of heat generated during operation possibly due to high frictional forces existing between the shaft and the bearings. The material of the crankshaft was identified as 40CrMnMo by chemical analysis [5].

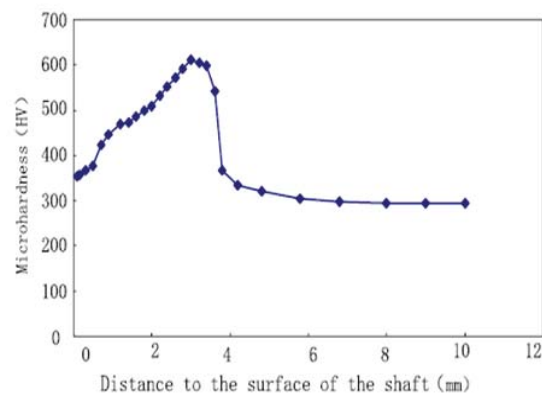
Figure 19. Variation of hardness along the surface of the shaft [5]

Hardness test of the specimen of the failed shaft showed variation between the hardness of the surface of shaft in where failure occurred and the other regions of the shaft. This was because of the thermal stresses acted upon the failed region which had caused the surface hardness to reduce and making it more vulnerable to fatigue failure. Further by investigating the images of scanning electron microscope it was observed there is variation in hardness within the material of the shaft from surface to core. Fracture analysis of the shaft revealed that the cracks causing the fracture initiated at three different regions and all had undergone different kinds of metallurgical changes finally

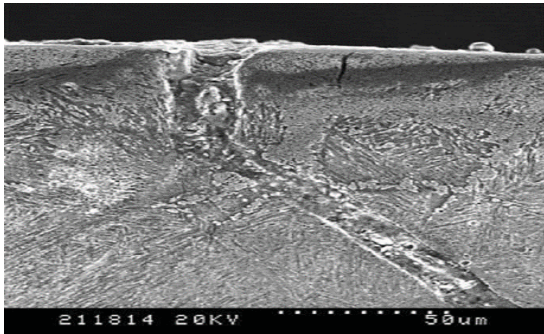
Figure 20. SEM image of first and second stage of crack [5]

resulting into the fracture. Detailed analysis of the grain boundaries showed that the grain boundaries along the surface are larger as compared to the one at the centre and that slip of grain boundaries in different slip angled planes are also observed [5].

Thus result of fracture analysis had concluded that multiple cracks had originated perpendicular to the shaft surface along the oil hole at the journal bearing region and had propagated via different slip planes leading to final fracture. Fracture analysis concluded the phenomenon of propagation of the crack which the cause of the crack was found by failure analysis method. The conclusion of the failure of the shaft could be traced back to the combined effect of friction between the shaft and the bearing or bushing assembly and the misalignment of the shaft bearing holes. Since all the bearings had not failed so the assumption of bad lubrication was ruled out and the cause was determined was the misalignment of the shaft bearing assembly because of which an unusual type of friction caused the temperature to rise very high and this resulted into development of very high thermal stresses. This unaccounted thermal stress caused the failure of the shaft [5].
