Fatigue Failures of Echanical Components

P.Rama Mohan Reddy

Abstract : The abstract describes major causes of mechanical failure of the engineering components or structure. Various level of materials performance is introduced. Failures due to fracture, fatigue, creep, wear and corrosion have been explained in order to understand the common mechanical failure. A case study on the failure analysis of has been presented with the recommendation to prevent the failure.

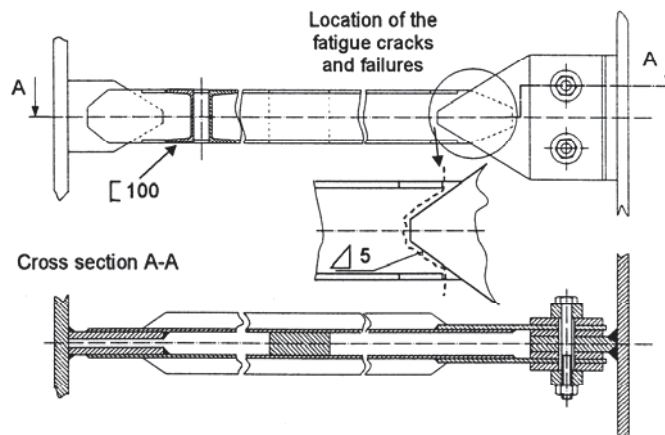
Figure 1. Lateral engine support with observed failures

Consequence of the cracking of the supports, figure 1, is obligatory stopping of the main engine. After this had happened, the crew usually had attached additional reinforcements until new supports have been finished. Therefore crack surfaces were not examined and only crack locations were known. Supports have been cracked or failure on the location marked on figure 1.

Also it was not known whether crack started from the middle of the beam and spread towards edges or vice versa. After cracking one of the supports, loads were probably redistributed, each time in a different manner. According to the description of cracks and failures, it was obviously that fatigue of material took a place again, and its causes should be detected by detailed stress analysis.

According to existing S-N curves for such weldments and determined maximal stresses, it is possible to predict the fatigue life of approx. 5×10^6 cycles, or a few weeks of service. This service life is too short, compared with expected 20 years. This prediction is in good agreement with the time to failure observed on former ships. Failures are mainly caused by inadequate joint design, of the support and ship (hull) structure from one side, and insufficient weld quality. Fatigue cracks at large portalcane.

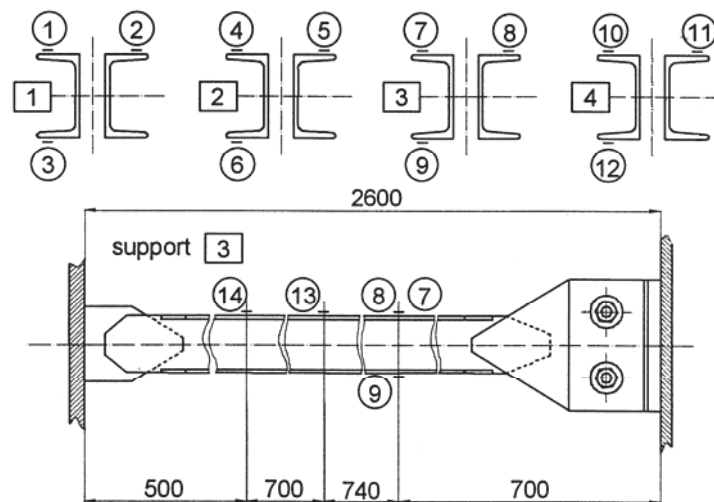
Figure 2. Setup of the measurements for nominal stresses determination

Due to complicated shape of crack area stress analysis was performed by means of strain gages. Strain gages were installed on all four beams (figure 2), in order to obtain operational loads (axial forces and bending moments).

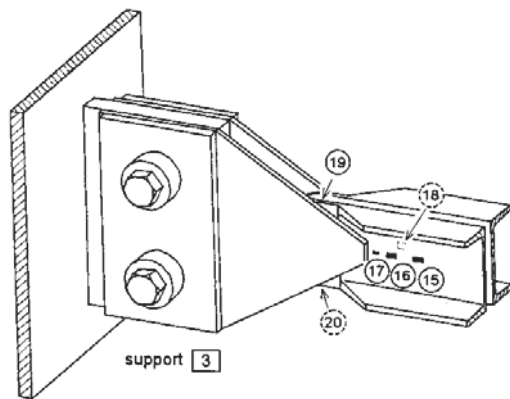
Figure 3. Strain gauges for local stress determination

The measurements took place during the sea trial of the new ship from the series. Measurement of local stresses was done at the locations of crack initiation spots, i.e. at the spot of the maximal stresses. As the observed bending moments were negligible, attention was put on the middle of the joint. In order to obtain maximal stress, three strain gages were applied (15-17), figure 3. As all four supports were not manufactured geometrically identical, on the other side of support 3, strain gage 18 is applied as well as gauges 21, 22, 23 on supports 1, 2, 4, respectively. The significant difference of measured axial forces between supports was discovered. One of the beams was loaded with approx. 50% lower load. However, maximal axial force $F = 20$ kN (calculated from the nominal stresses) was within the range of design load values. Measurements gave no significant bending moments. The results of nominal stresses ($\sigma = 10\text{--}15$ MPa) could not be the reason for fatigue cracks, in spite of observed differences from one support to others. Stresses at the crack initiation points were measured to evaluate the quality of design. Three strain gages (15, 16 and 17) were used for extrapolation of maximal stresses. Maximal stresses at the welds toe are extrapolated. Their amplitudes vary depending on weld design but measured values of 70 or even 80 MPa could easily cause the initiation and propagation of fatigue cracks.

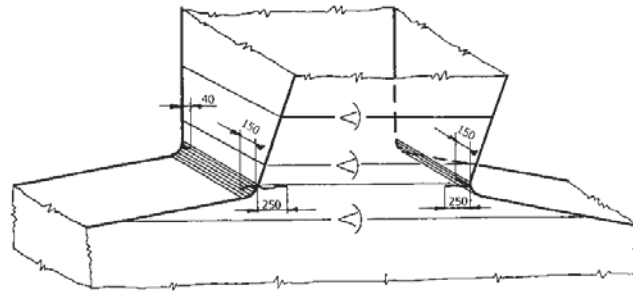
The cracks occurred at transition areas from vertical to horizontal supports on both legs, growing from the corners and bringing into danger the whole construction, figure 4. First cracks were detected soon after the crane was placed in the shipyard, so the allowed carrying capacity was reduced from 250

kN to 50 kN, but the crack

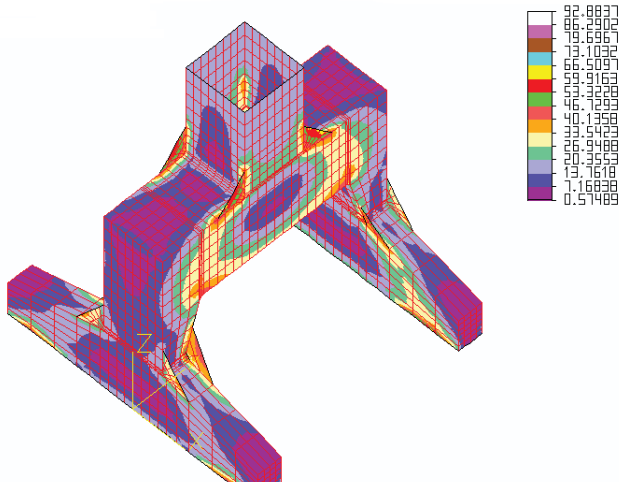
Figure 5. Typical stress distribution

17 variants, with various loads, with or without stiffeners, with different orientation of crane branch and including the weight of construction. Typical results of FEM analysis are shown on figure 5.

Strain gauge measurement and FEM analysis showed the source of crack initiation – high stress concentration in

stiffeners that fit the existing construction (figure 5). Those stiffeners were welded by using MAG process. The heat treatment was used to minimize the residual stresses and fatigue limit of welds was increased by grinding the weld toes and roots. After the repair was completed/

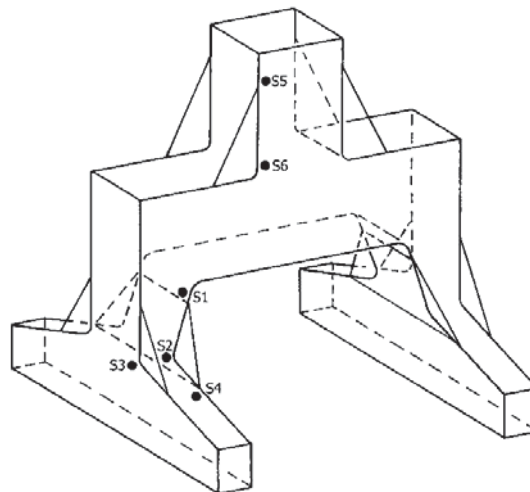
Figure 6. Positions of attached strain gauges

, stresses at critical points were measured once again and compared to the values predicted by FEM. Places where strain gauges were attached are shown on figure 6, and the results are shown in Table 1. Presented results are approximate, because the strain gauges cannot be attached

perfectly at the same positions. According to data from Table 1., it is clear that the stresses at critical points are significantly lowered, especially in critical areas. All the stresses are under the fatigue limit, so the main source for crack growth is removed.

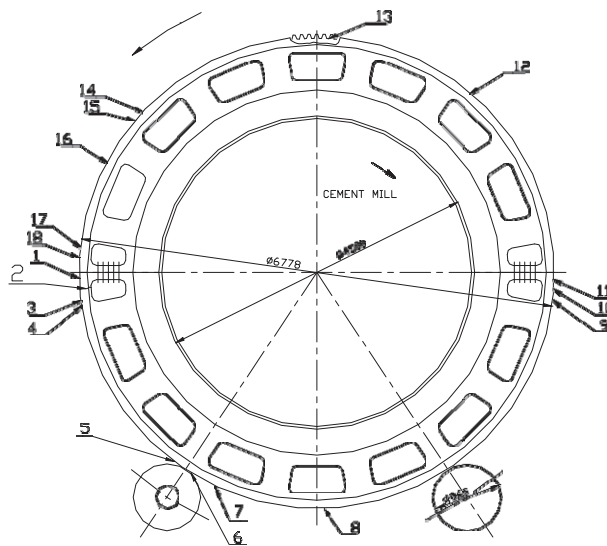
Figure 7. Detected cracks on cement mill

After 20 years in service, the great gear wheel of cement mill failed due to fatigue. When the whole mill plant was stopped and inspected, additional seventeen fatigue cracks have been found at the tooth fillets. The gear wheel was fabricated from cast steel and mounted in two ring parts at the front side of the cement mill, figure 7.

At several positions, very close to the surface, a lots of casting errors (pores, slag inclusions, etc.) have been found, figure 7. Joint efforts of alternating stresses, casting errors (sized several millimetres to several centimetres) and most likely existence of tensile residual stresses caused fatigue cracks initiation and propagation at the critical positions.

The cross section of the gear rim where complete fatigue failure occurred (fatigue crack No. 2), was additionally weakened by decreasing the rim thickness due to connecting bolts. The position of the cracks is showed on figure 7. The surface crack length varied from 20 mm to 600 mm (total failure). Position and size (surface length) of each discovered crack were estimated by means of non-destructivetesting.

to determine the stress distribution at the gear rim. Calculated maximum stress amplitudes have been found at the tooth fillet, approximately 50 - 115 MPa, depending on their positions at the surface. Stress intensity decreases very fast in the depth of the gear rim. These stress values could not be the only reason for cracks initiation and propagation. In spite of great number of cracks and one complete failure of gear ring, repair welding was performed. All necessary steps for the best quality insurance (best welders, best welding rods, pre-heating, very slow cooling conditions, NDT inspection following every layer, hammering of all layers, etc.) have been respected and documented. All described activities took two months and cost approx. \$50 000, instead of \$300 000 for new gear ring and four months for its delivery and montage. Three years after repair and frequent controls during the service, no further cracks have been reported.
