Failure Analysis for Angle Head Spiral Gears

Abstract: In this paper, a failure analysis for angle head spiral gears of CNC milling machines is investigated for discovering the failure reasons and so overcoming them in the future. Two spiral mating gears' set is of identical dimensions and its role is to convert the vertical motion to horizontal motion for a certain machining operations is studied in this research work. The gears are manufactured from carburized steel (18CrNiMo7-6), DIN standard No.1.6587. The gear module is 4 mm and number of teeth is 22 teeth. The gears have been failed after 2 weeks of operation. A visual investigation has been carried out and a set of photos were taken. The visual investigation showed that the gears have undergone some broken teeth. The operating conditions have been revised during consecutive intervals of operation. The design data has been reviewed according to standard gear design recommendations followed by a check for the manufactured gear data according to that design data. Material analysis and micro hardness measurements followed by a microstructure have been also investigated. Heat treatment faults were found.

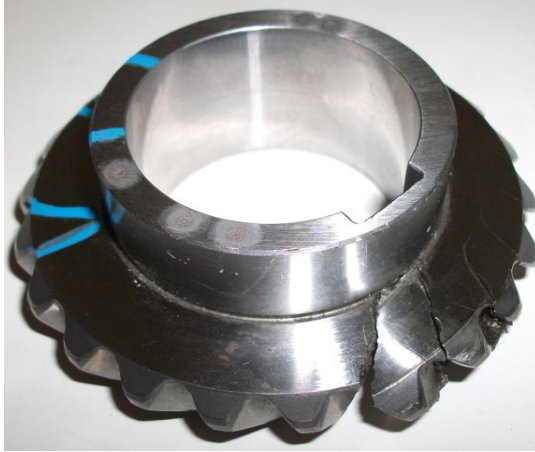
The visual observation of the original gear after failure had shown complete teeth separation at the keyway from outside and inside, as shown in figures (1, 2) which occurred after operation of about 20 years. Almost, the teeth were in good conditions except around the key way area.

Fig. (1) Original gear teeth cracks

Since the gear teeth hardness, case depth and microstructure were proper, and then the failure of the original gear has been occurred due to the fatigue cycles time for operation about 20 years. The failure may started with cracks at the key way due to the stress concentration at the keyway accompanied with a crack at that end as shown in figure (2). After cracks initiated, the small separated fragments were found between teeth, which have accelerated the cracks propagation and failure occurrence. This type of failure is classified as tooth bending fatigue [18].

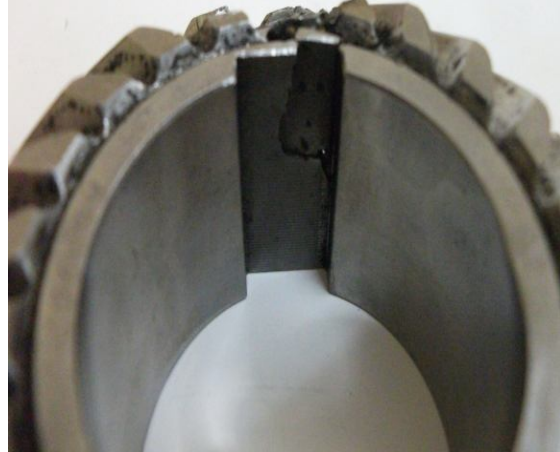
Fig. (2) Original gear keyway crack

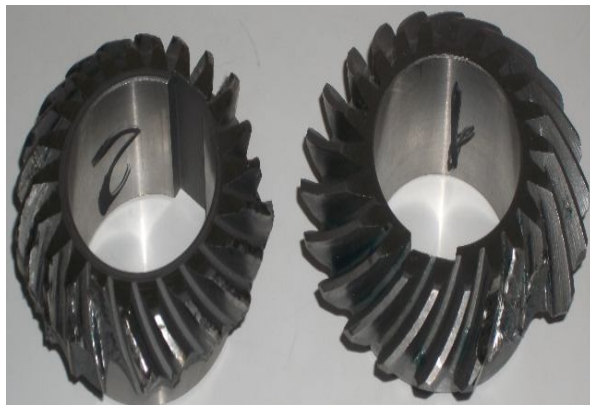
The manufactured gears had some broken teeth, but not at the key way and had not complete separation, as shown in figure (3). The gears' failure occurred within four weeks of operation.

Fig. (3) Manufactured gears after failure.

Gear (1) had some broken teeth and cracks at the keyway, as shown in figure (4) but not complete separation as the original gear, figure (2). Also, gear (2) had some broken teeth and cracks at the keyway, as shown in figure (5). Both manufactured gears had a severe pitting through the most of gears' teeth, as shown in figures (3, 4 and 5).

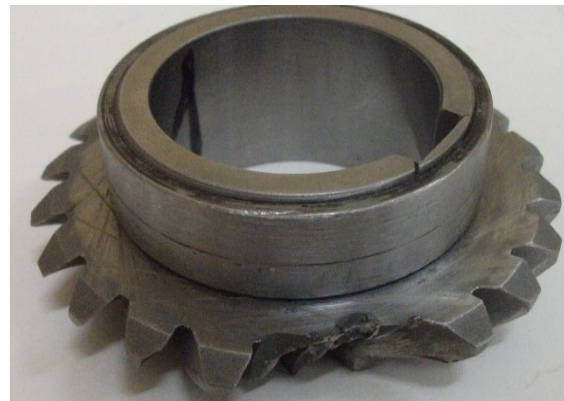
Fig. (4) Manufactured gear teeth breakage (1)

The failure has occurred, beside the stress concentration at the key way, due to the excessive retained austenite, which may help in initiating cracks at grinding operation after heat treatment, which propagates during operation.

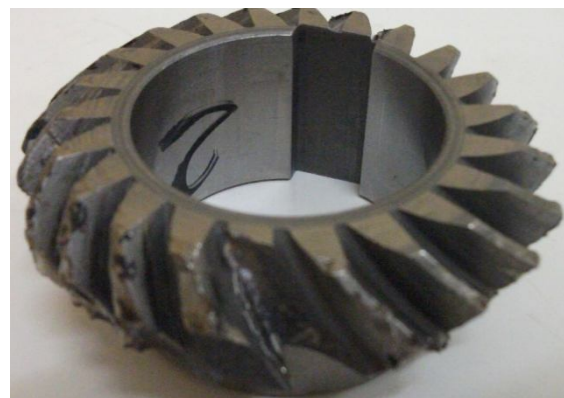
Fig. (5) Manufactured gear teeth breakage (2)

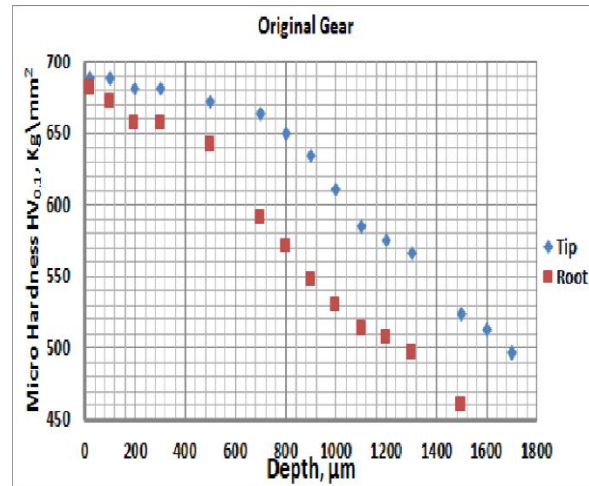
Fig. (6) Original gear micro-hardness

The surface hardness HV0.1 of the original gear = 670 – 690 Kg/mm², while the core hardness of the original gear = 430 Kg/mm².

The case depth on the teeth tip of the original gear = 1.6 mm, while the case depth at the teeth root = 1.2 mm

The micro-hardness between the root and the teeth showed an excessive carburizing depth compared to the gear teeth thickness.

The original gear micro hardness is confirming the recommended values ISO 6336-5 [4] and reference [5], as shown in table (1) and figure (6).

In addition, its case depth of 1.2 mm satisfies the recommended values presented in reference [17] (the case depth to be within 0.3- 0.4 module) which proposed for avoiding the teeth failure.

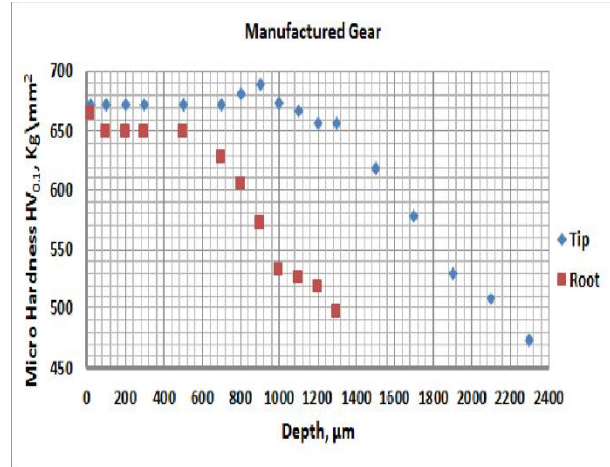
Fig. (7) Manufactured gear micro-hardness

The surface hardness HV0.1 of the two gears = 670 Kg/mm², while the core hardness of the two gears = 450 Kg/mm².

The case depth on the teeth tip of the two gears = 2.1 mm, while the case depth at the teeth root of the two gears = 1.2 mm.

The micro-hardness scan, the hardness at surface is less some points inside the case, shows that there a decarburization had occurred due to oxidation of carbons at temperature over 860 Co when transferring the gears from the carburization media to next heat treatment operation without cooling it in a reach carbon surrounding the gear to less than 860 Co [8, 20].

Case depth is more than the recommended value of 2.1 mm, which make a full-hardened portion at the tip of the teeth, which make this portion, lose its toughness and could not resist the impact loads due to the irregular machined surfaces of the welded work pieces. Too much case depth makes the gear teeth more brittle with the tendency to shatter off the top of teeth [17].

- The hardness value, for improving the Hertzian strength of gear teeth.
- Optimum case depth value, for avoiding thinner case, which leads to an initiation of cracks, or deeper case, which leads to shatter of the teeth at top.
- Avoiding decarburizing which leads to a drop in gear teeth hardness and increasing the retained austenite causing a crack initiation in teeth.
- The time and conditions of work piece transfer from carburizing furnace to the cooling furnace must be in reach carbon environment to avoid the decarburization.
- The time of work piece transfer from the hardening furnace to the quenching media to suitable to avoid the TTT intersection.

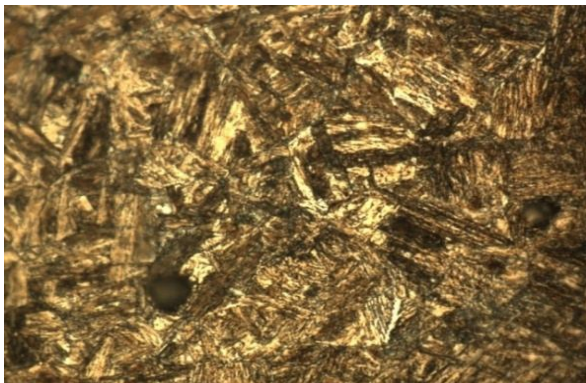
Figure (8) shows large martensite plates with small amount of retained austenite.

Fig. (8) Original gear teeth surface microstructure

Additionally, the martensite microstructure of the gear teeth with small amount of retained austenite is found to be adequate.

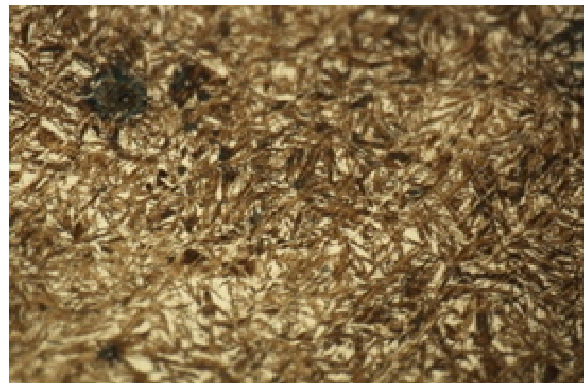
Whereas, figure (9) shows the teeth microstructure, which reveals small amount of martensite; black points in the microstructure.

Fig. (9) Original gear teeth core microstructure

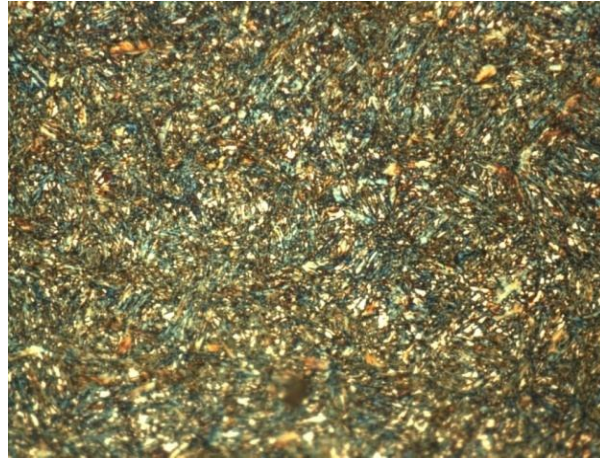
The microstructure of the manufactured gears, as shown in figure (10) at teeth surface reveals an amount of martensite with large amount of retained austenite.

Fig. (10) Manufactured gear teeth surface shows excessive retained austenite.

Excessive retained austenite at the surface decreased the Hertzian strength of the surface, which may cause pitting. Also, retained austenite decreased the toughness strength and accelerated the failure [19].
