Corrosion Behaviour of NIMONIC-90 Alloy

Abstract: Investigations were conducted on hot corrosion of Nickel base, NIMONIC-90 at 675°C and 725°C. The tests were carried out on small test coupons coated with a chemical containing Sodium sulphate and Sodium Vanadate which is representative of the corrosive deposit that usually forms during service in the coal fired boiler and the likes operating in marine atmospheres. Corrosion rates were measured by determining weight loss of the specimen after de-scaling. It was observed that there are three distinct stages in hot corrosion of Nimonic-90 under study. In the first stage the rate of corrosion is rapid and this is mainly due to the formation of corrosion products on new surfaces. In the second stage the corrosive reactions have become stagnant. At high temperatures the corrosive deposit fluxes the protective scale to make it possible. It takes some time before the deposit fluxes and penetrates the oxide scale to attack the substrate. This stagnant stage during which there is no attack can be called "Initiation period". In the third stage, the corrosion rate accelerates again and the rate of corrosion is increased by over two times that

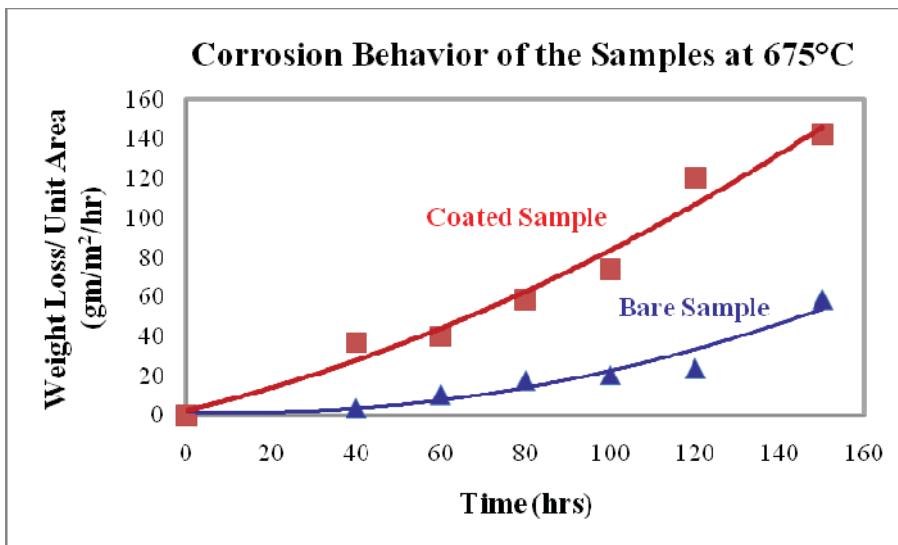
Figure 1: Corrosion behaviour of the samples at 675°C

As described earlier the scale formed during the hot corrosion experiments at 675°C and 725°C was dissolved out and weight loss was recorded with time. As can be seen from the Figures 1 and 2 the rate of corrosion increased continuously for the uncoated specimens. Rates of corrosion (Oxidation) have been calculated from the slope of the curve. It is found that rate of corrosion is 0.3 gm/m²/hr at 675°C and that at 725°C is 0.595 g/m²/hr. It is observed from the Figures 1 and 2 that there are three distinct regions in the case of specimens exposed to hot corrosion, both at 675°C and 725°C.

In the first stage the rate of corrosion is high. In the second stage i.e. flat portion of the curve there is no change in weight, which means that there is no attack by the deposit. In the third stage the corrosion rate again increases steeply. In the first stage freshly prepared samples were exposed to high temperature and corrosive atmosphere. Immediately due to the oxidation at high temperature and presence of corrosive coating, the rate of corrosion is high resulting in the formation of chromium oxide scales. The rate is given by the slope which is found to be 0.6g/m²/hr at 675°C and 2.9 g/m²/hr at 725°C. Hot corrosion is a deposit induced corrosion in which the rates of corrosion are aggravated by deposit in the liquid form. These liquid films have to penetrate and flux the protective oxide scales of Cr₂O₃ for further attack to take place i.e. there is some time lag before the actual hot corrosion process is initiated. During this period called "INITIATION PERIOD", the change in weight virtually remains constant. This is characterised by the presence of horizontal portion i.e. stage II in both the Figures.

Once the attack by hot corrosion starts the fluxing of the protective oxide layers takes place and protective oxide becomes porous. As the specimens have been coated with V₂O₅ and Na₂SO₄ which are acidic in nature thus resulting in acid fluxing already described in section 3.3.2. This produces a porous protective oxide. Further corrosive attack increased rapidly as can be seen from the third stage of the Fig. 1 and Fig. 2. This stage can be aptly described as the “PROPAGATION PERIOD”. The rates of corrosion have been calculated and found to be 1.6g/m²/hr and 2.6625g/m²/hr 675°C and 725°C respectively. It can be also been seen from the figures that the initiation period is shorter at higher temperature followed by the early onset of the propagation period. This is due to higher rates of diffusion, deposit being more fluid and hence fluxing of the protective oxide scale is faster at higher temperatures. The rates of corrosion in the stage III is almost double of that in stage I.

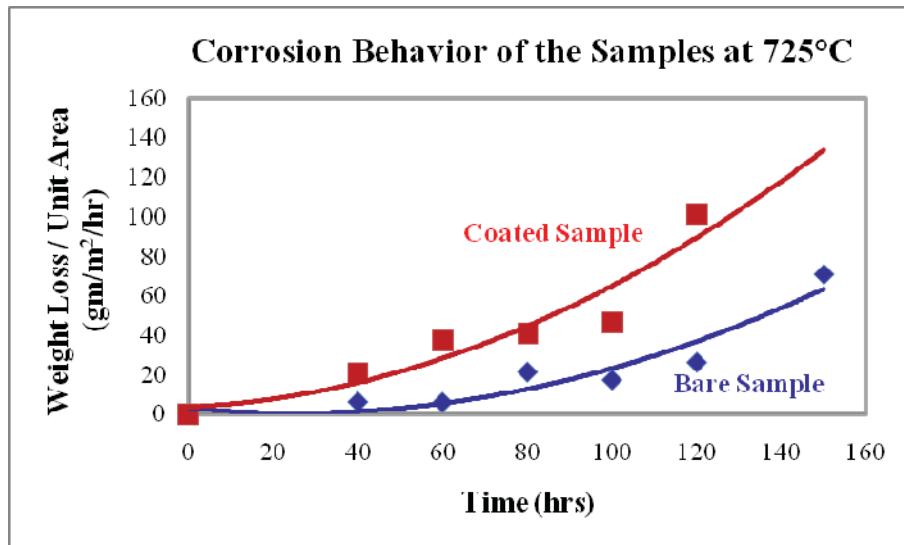
Figure 2: Corrosion behaviour of the samples at 725°C

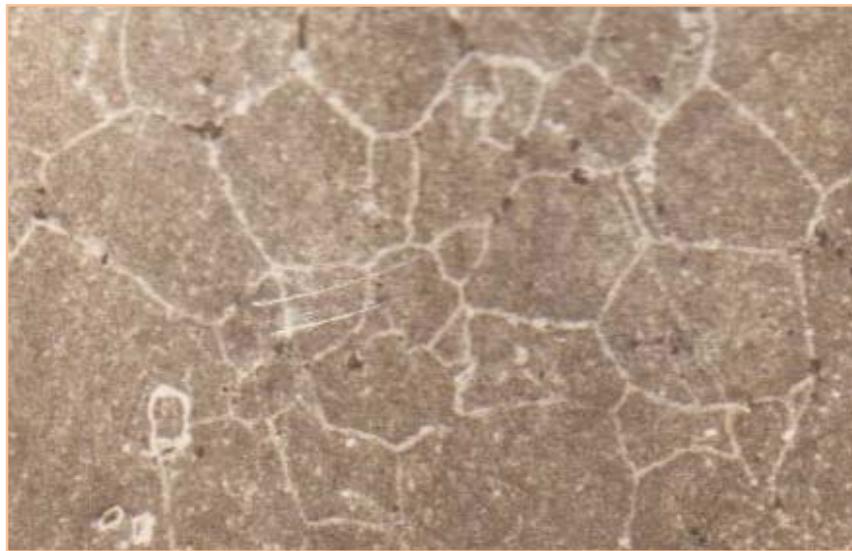
Figure 3: Microstructure of bare sample held at 725°C for 100 Hrs at 350X

The uncoated samples and the samples exposed to hot corrosion were suitably prepared for metallographic examination. The microstructures are presented in Figures 3 to 8. As can be seen from the microstructure of the raw sample in Fig. 3, a combination of coarse and fine grains is present. The grains are relatively coarser in the sample heated to at 725°C for 40 hrs. Some of the grain boundaries are also observed to be attached by the coating as there is a broadening of the grain boundaries (Fig. 4). It is observed that the attack by the deposit has increased with the progress of time from 40 hrs to 100 hrs. (Fig. 5) and 150 hrs (Fig. 6). Figure 7 shows the microstructure of the sample held at 675°C for 150 hrs at a higher magnification. From the above observations

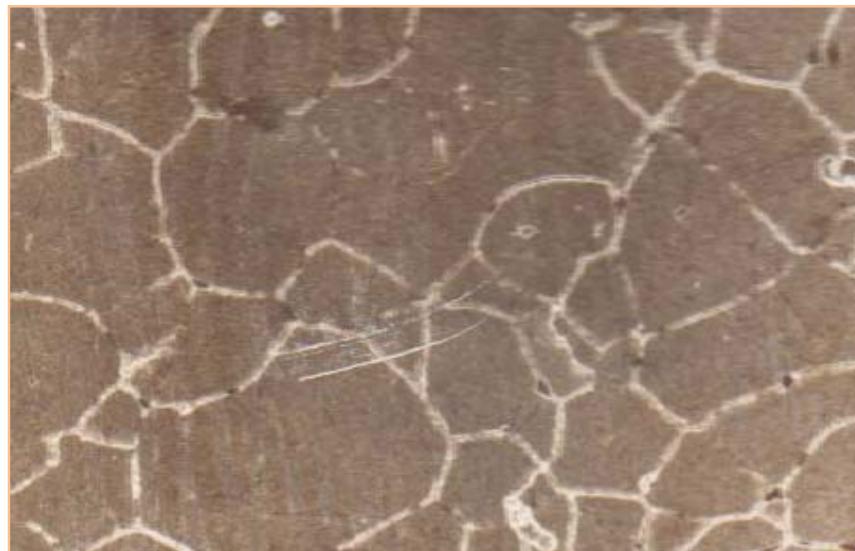
Figure 4: Microstructure of coated sample held at 725°C for 40 Hrs at 350X

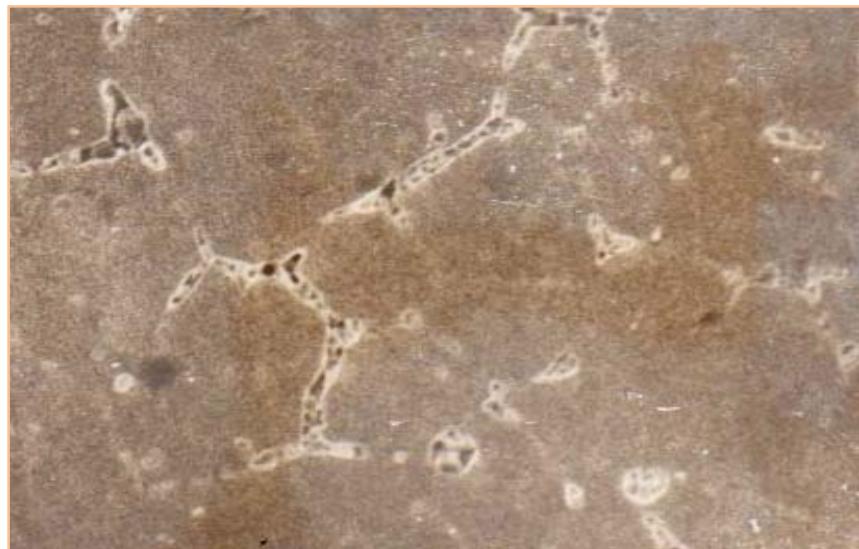
Figure 5: Microstructure of coated sample held at 725°C for 100 Hrs at 350X

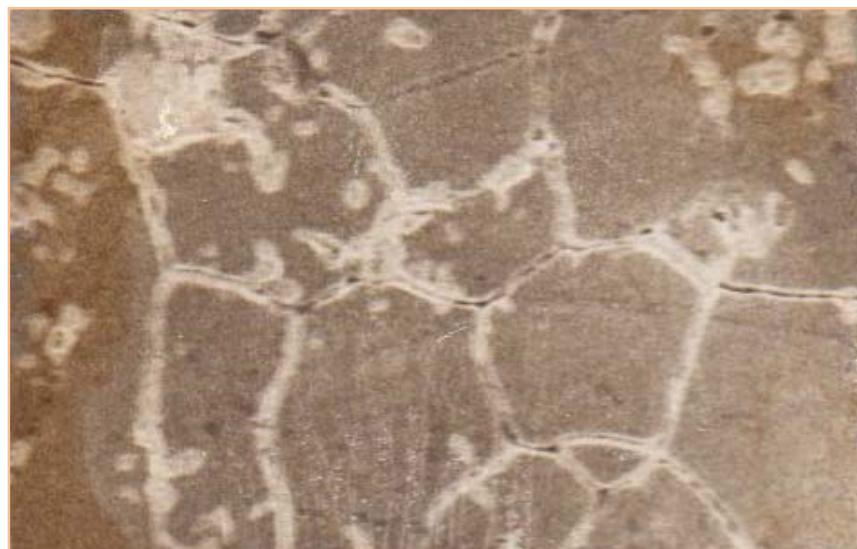
Figure 6: Microstructure of coated sample held at 725°C for 150 Hrs at 350X

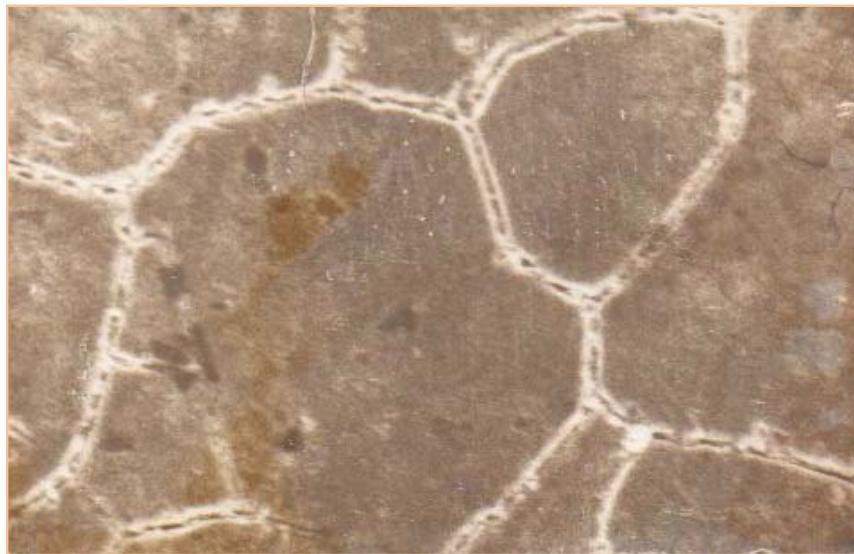
Figure 7: Microstructure of coated sample held at 675°C for 150 Hrs at 500X

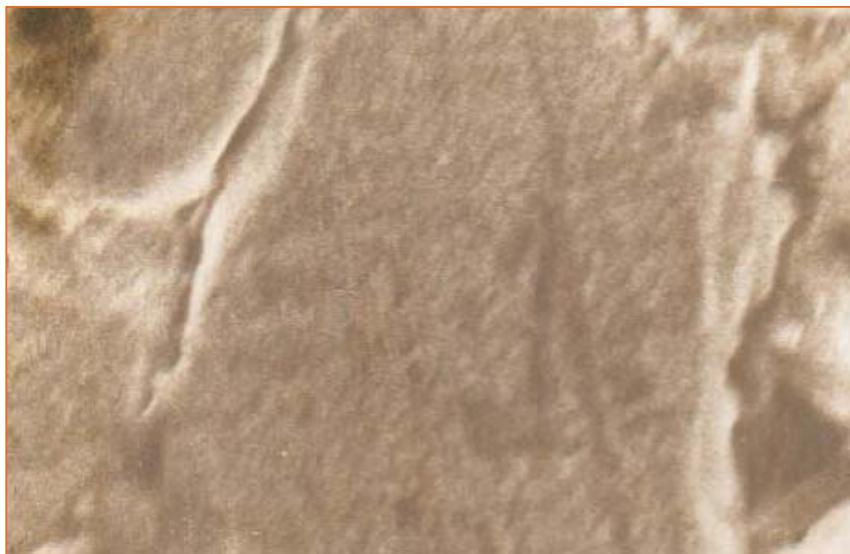
Figure 8: Microstructure showing scale formation on the surface at 1000X

it is clear that the extent of corrosion is more significant at 725°C than at 675°C. The micrograph in the Fig. 8 reveals the scale formation due to hot corrosion on the surface.
