# Experimental Study on the Effect of Certain Repair Materials Applied to Concrete Beams

**Abstract-** The effectiveness of a repair work for the restoration of spalled reinforced concrete(R.C structures) depends to a great extent, on their ability to restore the structural integrity of the R.C element , to restore its serviceability and to protect the reinforcements from further deterioration. This paper presents the results of an experimental study to investigate the structural performance of eight spalled R.C beams repaired using repair materials (Micro Concrete) namely a free flowing self compacting mortar along with polypropylene and steel fibres with various percentages. The repair technique adopted was that for the repair of spalled concrete in which the bond between the concrete and steel was completely lost due to reinforcement corrosion or effect of fire or impact. The beams used for the experiment were first cast and then hacked at maximum flexure zone before they were repaired except for the control beam . The beam specimens were then loaded to failure under two point loadings. The structural response of each beams was evaluated in terms of first crack load, cracking b

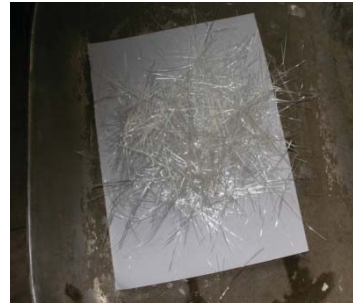
Polypropylene fibre

S.No	Properties	Steel fibre	Polypropylene fibre
1	Length	35mm	20mm
2	Diameter	0.5mm	40micron
3	Aspect ratio	77.78	500
4	Young's modulus	1000mpa	500mpa

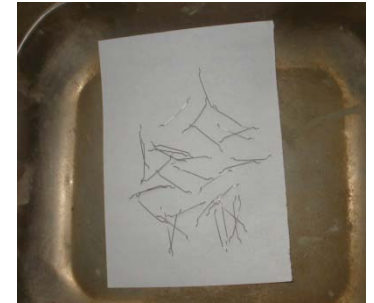
Steel Fibre

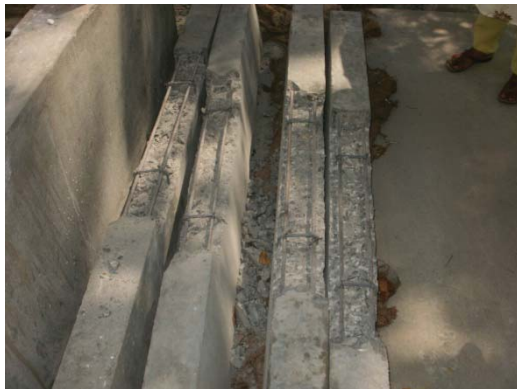
Spalled specimen

Loose and unsound concrete in the flexural zone along the length of the reinforcement beam were cut away by means of a steel chisel. The resulting grit and dust were removed by means of a wire brush.

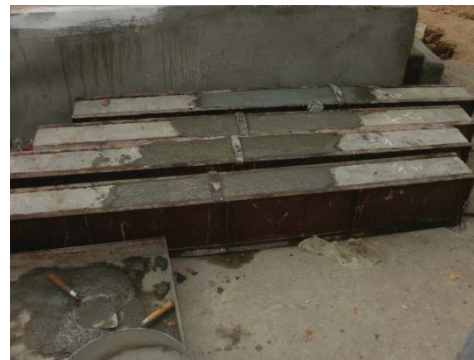
Application of repair materials

Steel formworks were used in repair works to give the repaired areas their desired shape. A few hours prior to the repair work the substrate was properly saturated by filling the formwork with clean water. The water was then drained just prior to the commencement of the repair work and the formwork was made leak proof by the free flowing nature of micro concrete. The micro concrete was mixed with clean water to a trowable consistency as

recommended by manufacturers. Epoxy bonding agent was then applied on the surface of steel and parent concrete as bonding bridge before the repair material was applied.

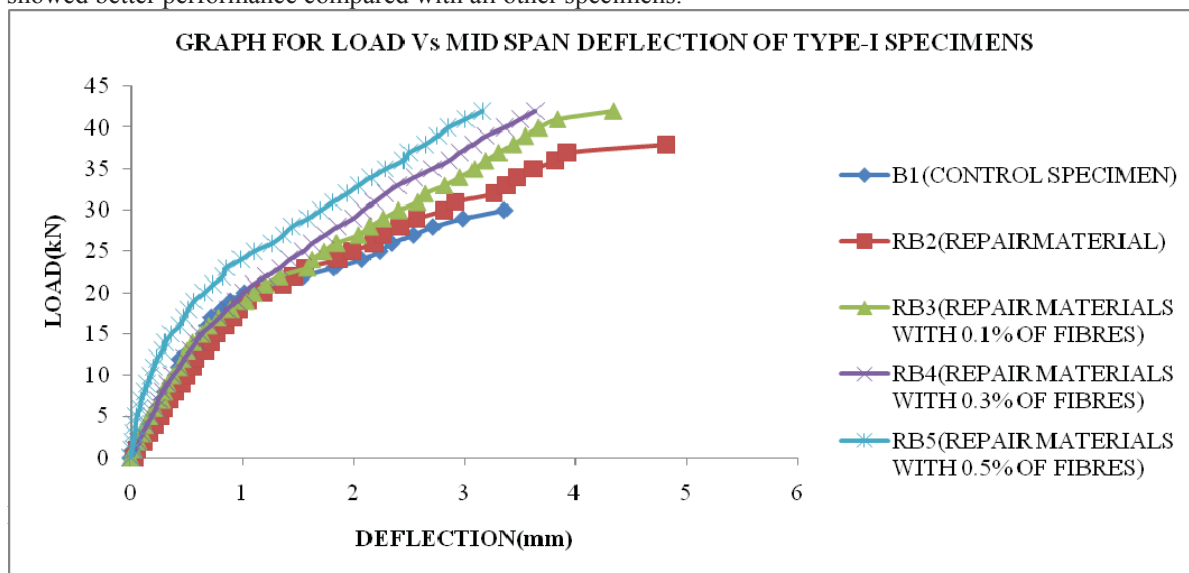
The mid span deflection curves for beams repaired with repair materials along with polypropylene and steel fibres as well as for the control specimen were shown in fig. the actual maximum deflections at mid span were measured and plotted against actual loads. The beam specimens repaired by using repair materials along with polypropylene and steel fibre showed almost similar load deflection curves to that of the control beam. Among these RB4 and RB5 showed better performance compared with all other specimens.
