Fault Diagnosis of Windmill by FFT Analyzer

Abstract- Wind energy conversion is the fastest growing source of new electricity generation in the world. Wind mills are located in harsh environment so their maintenance is very difficult. Wind mill consist of various parts such as blade, gearbox, tower, generators etc. Wind faults are mostly occurs in the gearbox, bearing, blades. The traditional fault diagnosis methods such as fast Fourier transform is used in this project. This present work deals with the occurrence of fault in wind turbine are investigated by using vibration analysis by using FFT analyzer and validate this results by MATLAB. There are various techniques are used for simple analysis of fault such as side band ratio [SBR], defect frequency for bearing and blade pass frequency for wind turbine blades. SER calculates the ratio of side band energy to gear mesh center frequency. It has demonstrated high sensitivity to gear damage in several cases. The failure of rotating machines is very critical and this leads to damages, losses of energy, personal injury, so it is very important duty of the maintenance department to prevent the fault of wind turbine. Vibration analysis

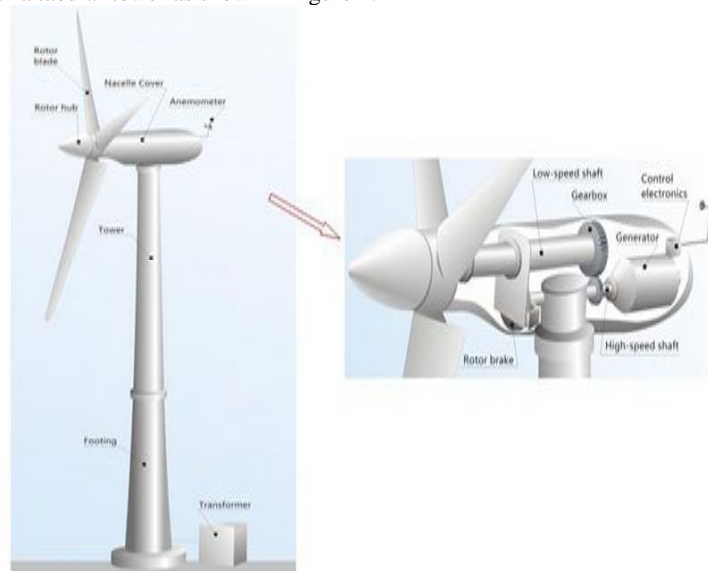
Figure. 1.1 Detail view of wind turbine

Wind energy is a free, renewable resource so no matter how much is used today. There will still be the same supply in future. Wind turbines harness the power of the wind and use it to generate electricity. Instead of using electricity to make wind like a fan wind turbine use wind to make electricity. The proposed wind turbine is a 'horizontal axis' machine which consist of three rotor blade turning around a horizontal hub. The hub is connected to gearbox and a generator which are located inside a nacelle. The nacelle houses the mechanical and electrical components and is mounted on the top of a tabular tower as shown in figure 1.1

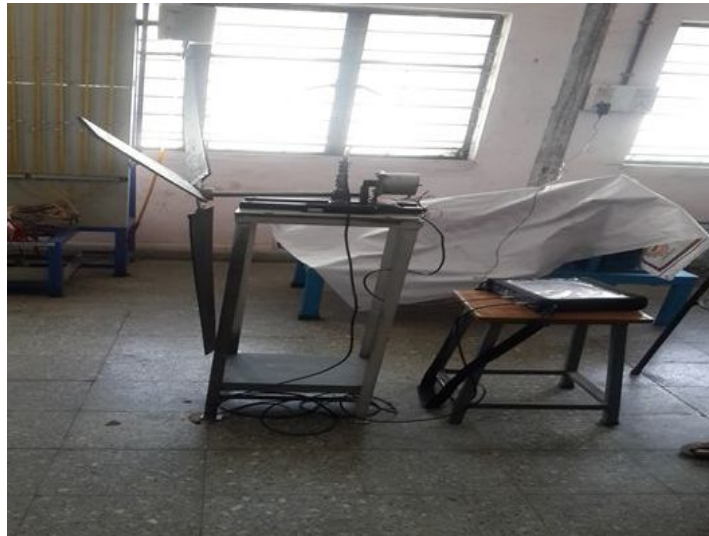
An experimental test rig built up to predict defects in unit of wind turbine as shown in figure(). The test rig consist of a shaft with central rotor which is supported on two bearing. Motor is coupled to the shaft. A pair of spur gears with module of 1.25mm is tested. The driving gear has 58 teeth and driven gear has 20 teeth. The

speed controller of gearbox operation is in range of 80-300 rpm. Blades are attach at the front end of shaft. Size of blade is 30 inch. This total assemble is mounted on tower whose height isc37.5inch .vibration characteristics are very important for study of diagnostic for fault. In the experiment setup consider all parts of wind turbine such as shaft, blade, gearbox, bearing with defect and without defect. All the part was attached to assembly one by one for carry the result. Dimensions of all parts are mention in design part. After taking the results it was seen that the value of amplitude and displacement was more for the all parts with defect compare to parts without defect. It was seen at the time of processing the data that for the defected parts the value of amplitude was increasing when frequency of the nearby natural frequency of the system. The various value of acceleration, velocity for the study of vibration characteristics were taken and these are shown in the figure respectively.

Fig 4.1 Experimental setup of windmill with FFT analyzer

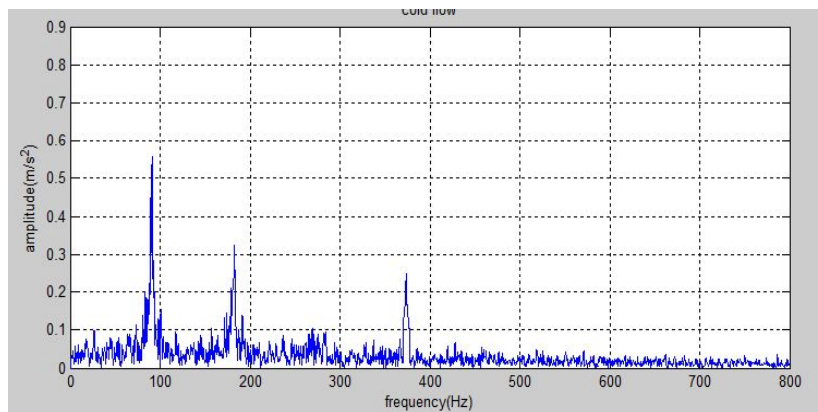
Figure 5.2.4 cold flow of pinion

Figure shows a picture of cold flow piniontooth during the inspection. All plots were generated by MATLAB software. In the spectrum plot shows first three harmonics of gear mesh frequency are denoted as 1X, 2X and 3X etc. Each gear mesh frequency has six side band frequencies which represents the expected location. The SER value for healthy pinion is always less than one. From the above figure the 1X,2X and 3X frequencies are 2.62,1.84 and 6.09 resp. SER value seen here indicates a defect on pinion is presented.

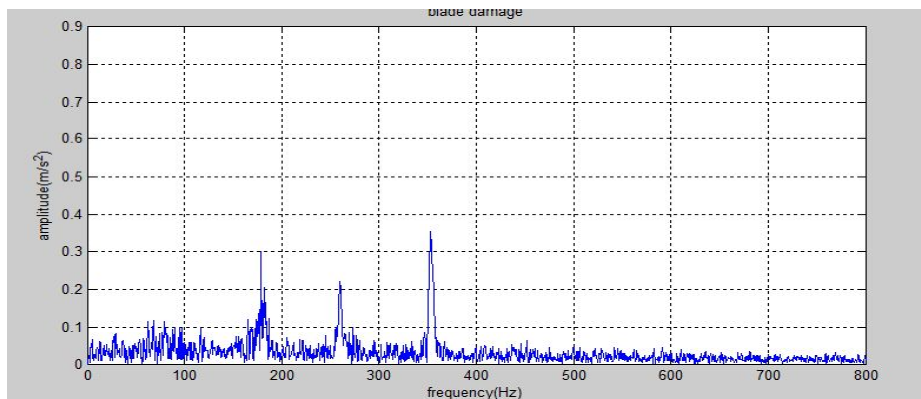
Figure 5.3.1 Blade damage

Figure shows a picture of spectrum plot of blade damage of wind mill. This damage occurs due to environment problem, lightening effect etc. The analysis of faults in the blades can be done by using blade pass frequency (BPF) technique. Blade pass frequency is calculated by the product of number of blades and its respective running speed.

$$\text{BPF} = 3 * 85.9 = 257.7 \text{ Hz}$$

Blade pass frequency is generated at 257.7 Hz then for next blade pass frequency it increases twice.
